**Flood Control Project Maintenance****2012 Structure Summary Report****Overall Unit and Item Ratings****Reclamation District No. 0999 Netherlands****Elk Slough Inlet Structure**

**Flood Control Project Maintenance****Unit Cover Sheet****2012 Structure Inspection Results****Reclamation District No. 0999 Netherlands**

Structure
Elk Slough Inlet Structure

Structure Rating	<b>A</b>
Date of Inspection	<b>7/18/2012</b>
DWR Inspector	<b>Richard Willoughby</b>
Accompanied By

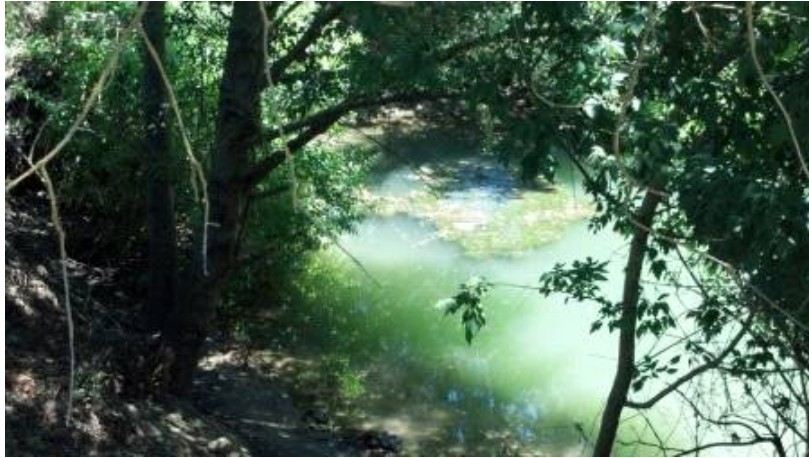
Levee Mile Report Line	1
Start Levee Mile	
End Levee Mile	
Location	
Category	Structures
Item	Photo Documentation
Looking southeast at inlet on slough side (inlet underwater)	
richard_t_20120802_170.jpg

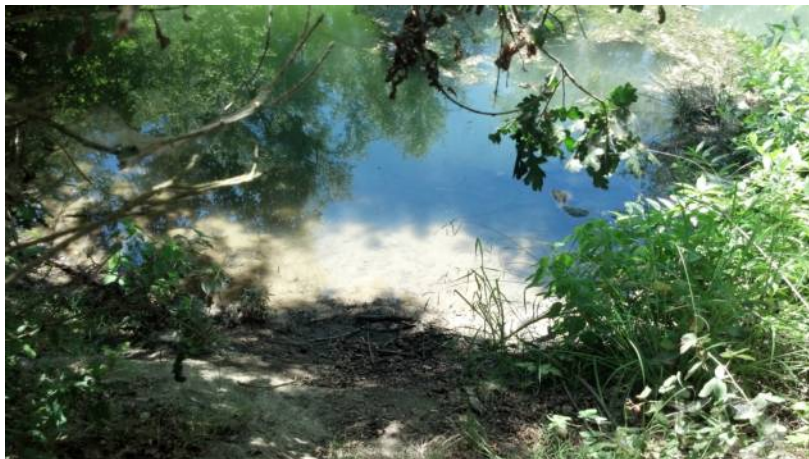
Levee Mile Report Line	1
Start Levee Mile	
End Levee Mile	
Location	
Category	Structures
Item	Photo Documentation
Looking west at inlet on slough side (inlet underwater)	
richard_t_20120802_171.jpg

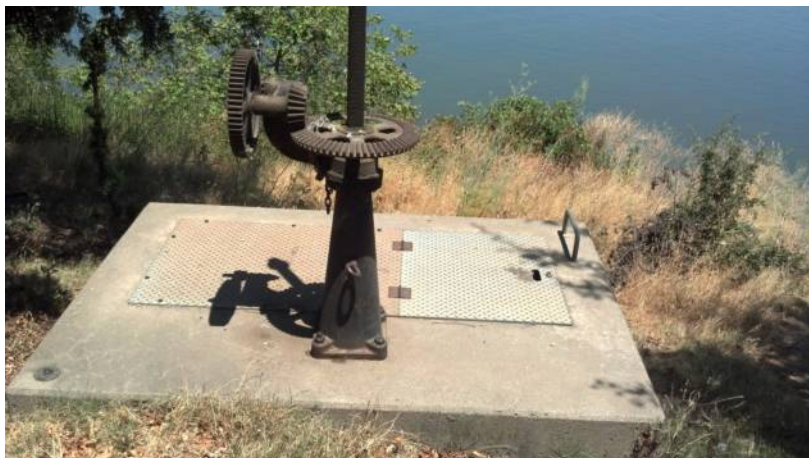
Levee Mile Report Line	1
Start Levee Mile	
End Levee Mile	
Location	
Category	Structures
Item	Photo Documentation
Looking northeast at manual gate on waterside of levee.	
richard_t_20120802_172.jpg

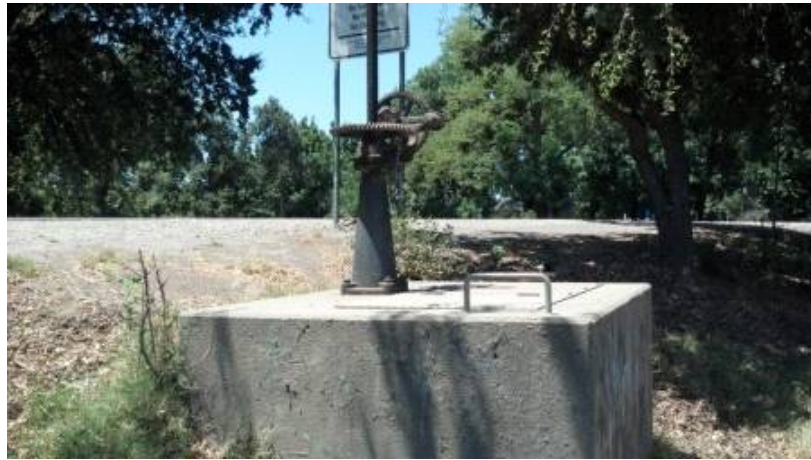
Levee Mile Report Line	1
Start Levee Mile	
End Levee Mile	
Location	
Category	Structures
Item	Photo Documentation
Looking southwest at manual gate on waterside of levee.	
richard_t_20120802_173.jpg

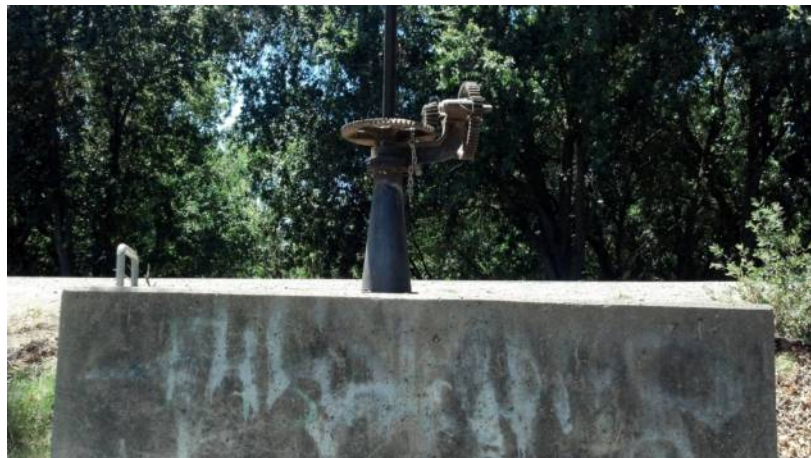
Levee Mile Report Line	1
Start Levee Mile	
End Levee Mile	
Location	
Category	Structures
Item	Photo Documentation
Looking west at manual gate on waterside of levee.	
richard_t_20120802_174.jpg
